ENVIRONMENTAL AND SOCIAL MANAGEMENT PLAN (ESMP) FOR THE REHABILITATION OF KAIBOCHE EARTH DAM PROJECT CHIAKARIGA WARD THARAKA SOUTH SUB COUNTY THARAKA NITHI COUNTY

OCTOBER 2018

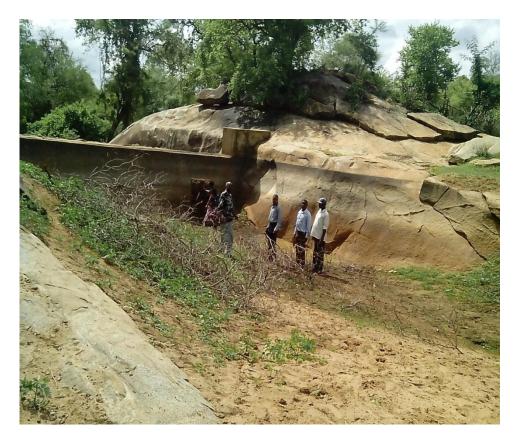
Project site before intervention

The need to rehabilitate the dam was occasioned by siltation that has greatly reduced the dam storage capacity to almost 2,000 M³. In the process of rehabilitation of the dam several activities are going to be undertaken, among them:
