ENVIRONMENTAL IMPACT ASSESSMENT

PROJECT REPORT

PROPOSED LELESHWA (MONICA) WATER PAN REHABILITATION PROJECT WITHIN SIPILI LOCATION, SIPILI
DIVISION IN LAIKIPIA WEST SUB-COUNTY OF LAIKIPIA COUNTY

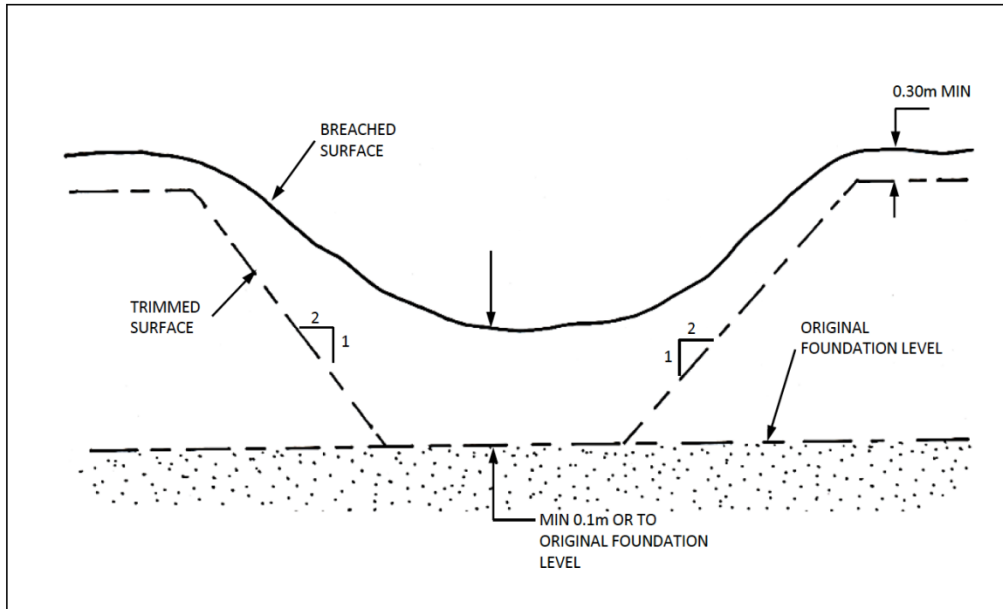
Figure 1: Trimming a breached embankment

All trees and vegetation will be removed from the old (possibly eroded) embankment, after which the embankment will be trimmed down. Any loose material will be removed or stockpiled for reuse. The trimmed old embankment is used as an upstream core for the construction of the new embankment. Suitable soil will be used for the fill, and the usual compaction procedures will followed. The core-trench will be incorporated in the new embankment. Care will be taken to ensure a good contact between the old and new sections of the embankment, and between the foundation and new material.
