ENVIRONMENTAL IMPACT ASSESSMENT

PROJECT REPORT

**PROPOSED MUTUIKU EARTH DAM REHABILITATION PROJECT WITHIN NGINYII VILLAGE IN
UMANDE SUB-LOCATION, UMANDE LOCATION, LAIKIPIA EAST SUB-COUNTY OF LAIKIPIA
COUNTY**

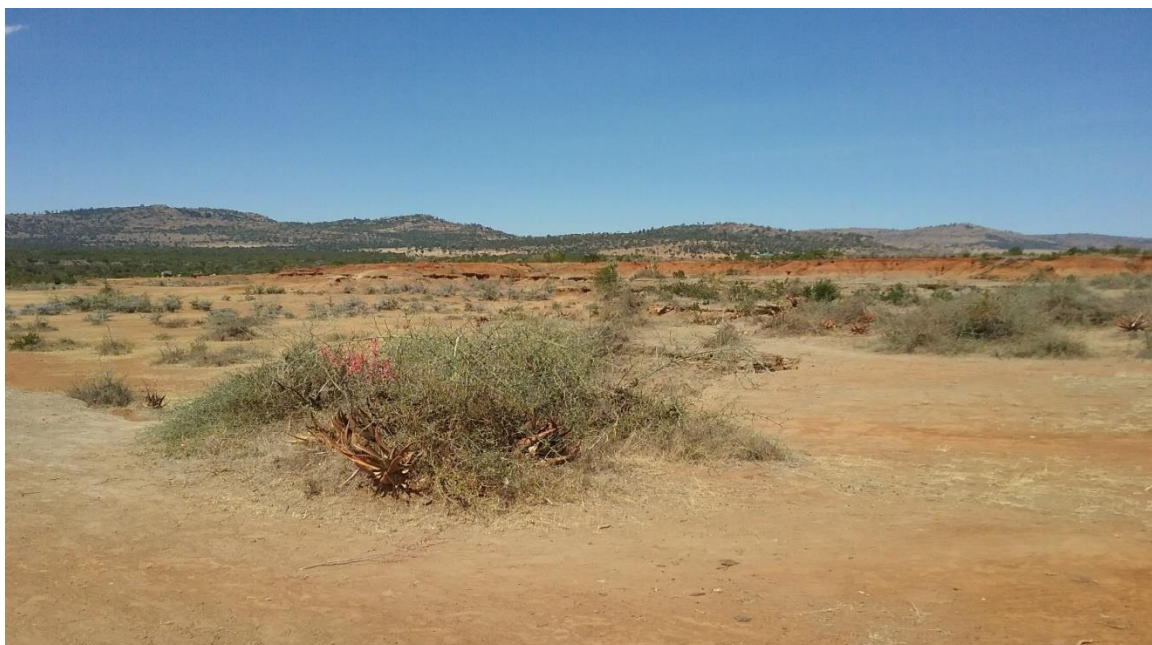
Figure 3: Mutuiku earth dam site

The proposed Mutuiku earth dam site is located within within Nginyii village in Umande Sub-location, Umande location, Laikipia East Sub-County of Laikipia County at a GPS and altitude of **N00⁰ 07' 19.5" E037⁰ 07'11.4" and 1892 Metres above sea level** respectively.
